# Seismic Response of an Existing Reinforced Concrete Building

Bugra Barin, Devanshu Kant, Olga Reyes and José A. Pincheira

Department of Civil and Environmental Engineering

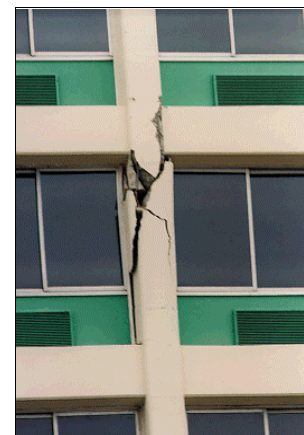
Typical damage in the fourth story columns.
